Manhole Inspection Summary

Manhole # S21G__015MH

Insp Date: **8/23/07 8:27 AM**

Location Address: **111 BRUCE ST**

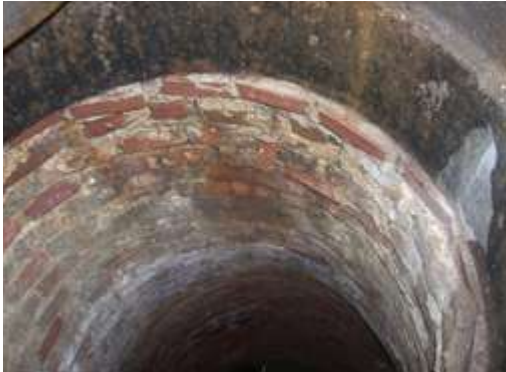
Defect 4

Infiltration: ☐ None ☒ **Joint** ☐ Cracks ☐ Mortar ☐ Roots ☐ Wall

INFILTRATION OF THE JOINT

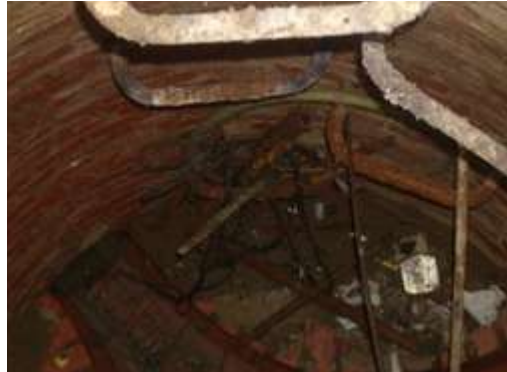
Defect 3

Count: **6** Missing: **0** ☒ **Corroded**

CORRODED STEPS

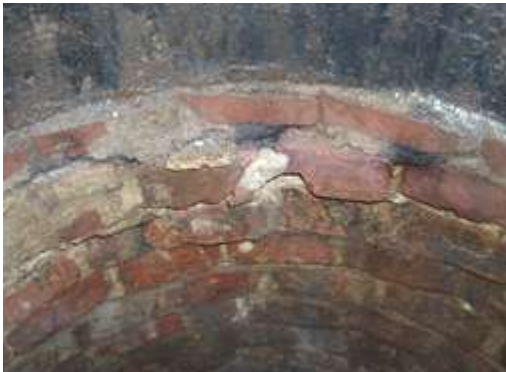
Defect 2

Condition: ☐ Sound ☐ Cracked ☐ Root Intrusion ☐ Loose Brick ☒ **Deteriorated**

DETERIORATED CORBEL

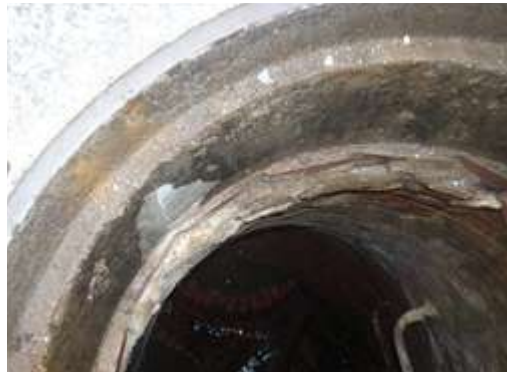
Defect 1

Offset: **1** (in.)

FRAME OFFSET

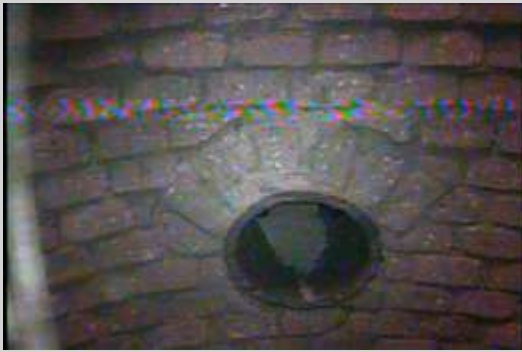
INFILTRATION OF THE JOINT

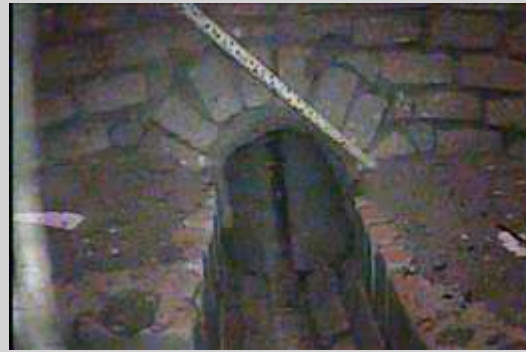
INFILTRATION OF THE JOINT

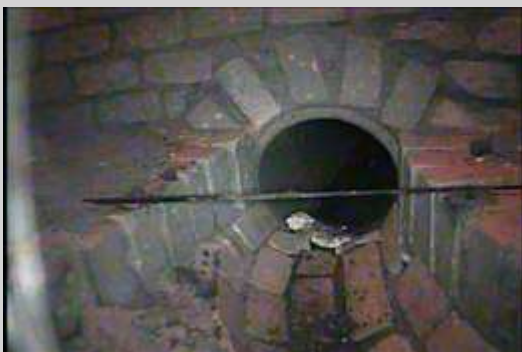
9 O'Clock Inflow

Deposits: ☐ None ☐ Mud ☐ Sludge ☒ **Debris** ☐ Grease

Silt Depth: **1** (in.) Deposits Extent: **Light**
